Manhole Inspection Summary

Manhole # S43M__002MH

Insp Date: **12/18/08 12:12 PM**

Location Address: **1629 thames st**

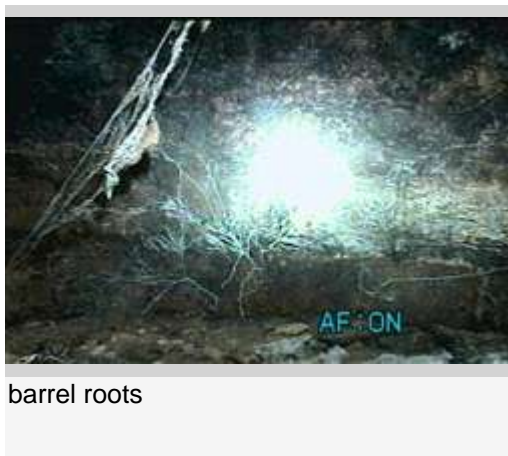
Defect 4

Condition: ☐ Sound ☐ Cracked ☒ **Root Intrusion** ☐ Loose Brick ☐ Deteriorated

barrel roots

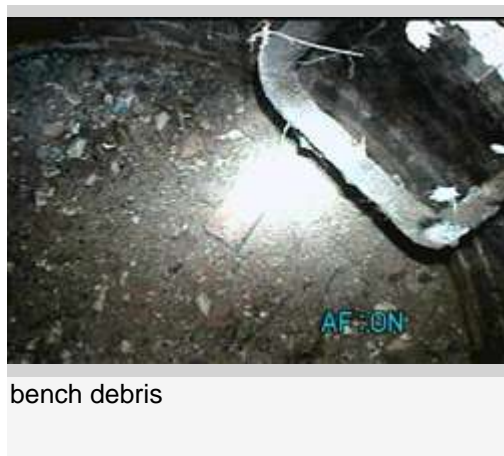
Defect 3

Condition: ☐ Sound ☐ Cracked ☐ Root Intrusion ☐ Deteriorated ☐ Leaks ☒ **Debris**

bench debris

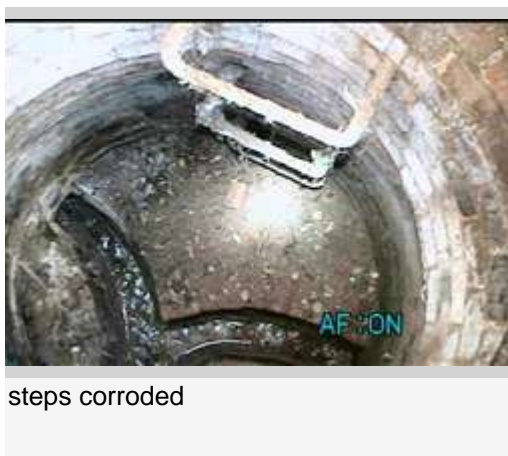
Defect 2

Count: **3** Missing: **0** ☒ **Corroded**

steps corroded

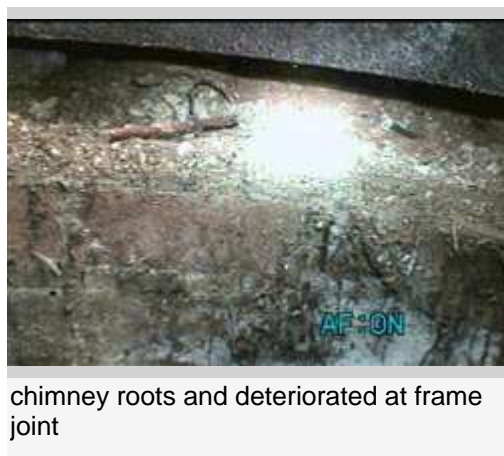
Defect 1

Condition: ☐ Sound ☐ Cracked ☒ **Root Intrusion** ☐ Loose Brick ☒ **Deteriorated**

chimney roots and deteriorated at frame joint

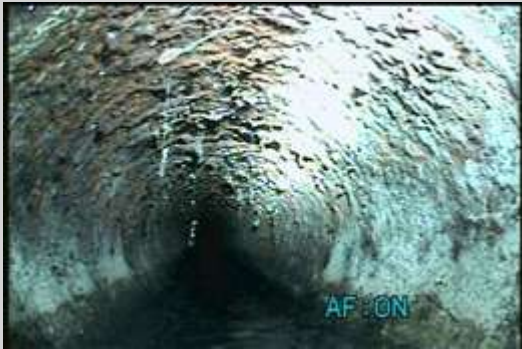
12 O'Clock Outflow

8 in. Circular Gravity Sewer
Pipe Out @ 12 O'Clock

Pipe Seal Cond: **Roots**

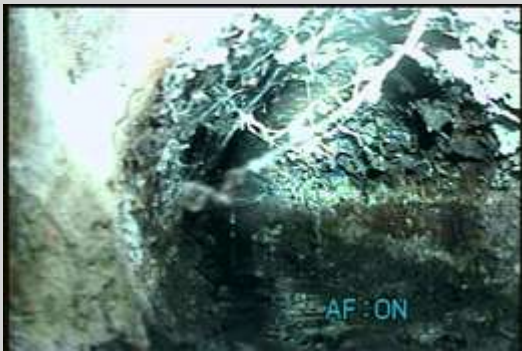
3 O'Clock Inflow

6 in. Circular Gravity Sewer
Pipe In @ 3 O'Clock

Pipe Seal Cond: **Roots**

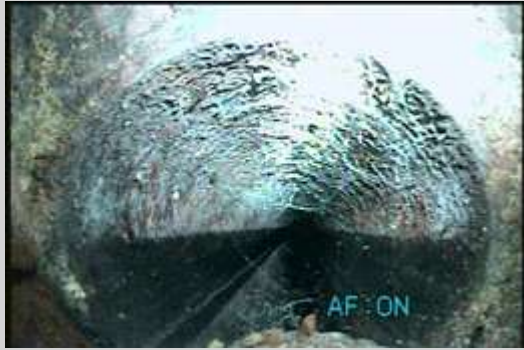
9 O'Clock Inflow

6 in. Circular Gravity Sewer
Pipe In @ 9 O'Clock

Pipe Seal Cond: **Roots**
